**Flood Control Project Maintenance
Levee Inspections**

Fall 2018 Levee Maintenance Deficiency Summary Report

San Joaquin River Basin

Reclamation District No. 2062 Stewart

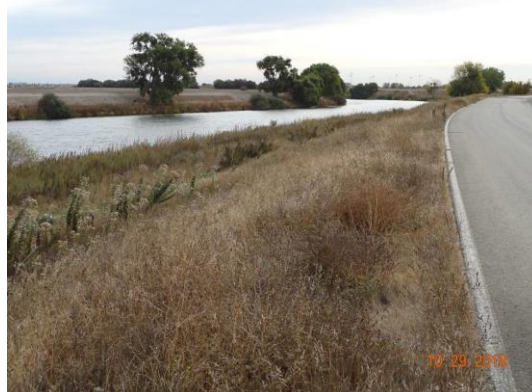
Photo 1 of 1 : FA_2018_RD2062_309_6_20181101_00010.jpg

LM Start	0.00	Rating **	M	Issue No.	6
LM End	2.63	Issue Type +	Ma	Location *	N/A
Category	Earthen Levee			GPS Latitude/Longitude	
				Start	End
Item	Vegetation			37.807505 °	37.787249 °
				-121.328103 °	-121.308947 °
DWR ID	DWR_RD2062_01_f_2018_6				
Comment Code					
V1 : Control annual grass and weeds on the levee slopes and easements.					
Inspector Comment

Typical view of levee slopes.

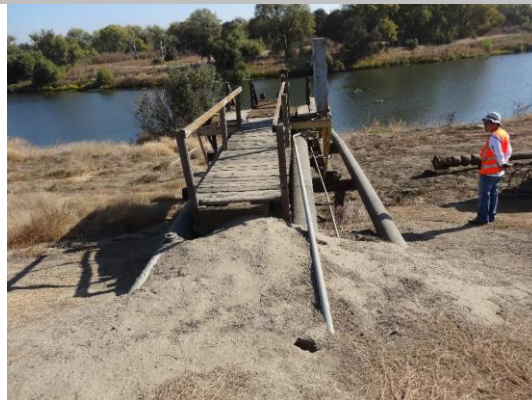
Photo 2 of 3 : UCIP_FA_2018_22807_38904.jpg

Comment Code						
Inspector Comment						
FS_ID:22807 DS_ID:19177 EP_NO: 12679 Repair Type: Non-Urgent Crossing Status: Found UCIP Comments: - All 3 pipes on landside looks new.- Pumps, pump house, and pipes removed from waterside.- Land development activities going on in this area.- Needs to confirm from LMA or DWR Inspector about the crossing. FIELD_STRUCT_DESC: 1 of 3: 16-inch steel irrigation discharge pipe through the levee, 5 feet below the crown. Electrical conduit through the levee. Slant pump in a pump house on the waterside (WS) slope. Siphon breaker on the landside (LS) slope. Service pole and concrete gate valve box at the landside (LS) toe. Installed by USACE in 1961. (Plans to replace rusted portions of two 16-inch irrigation pipes through the levee authorized under Permit No. 16124, 1993 - Reclamation District No. 2062). [Additional Reference(s): DWR Levee Log, 2007. USACE San Joaquin O&M Manual 9, April 1964, (HLM 1.65)]. FS Date: 10/22/2013

LM Start	1.64	Rating **	M	Issue No.	9 (cont)
LM End	1.64	Issue Type +	En	Location *

WS view: 16-inch pipes on both sides of walkway and 10-inch pipe (on right) away from walkway.

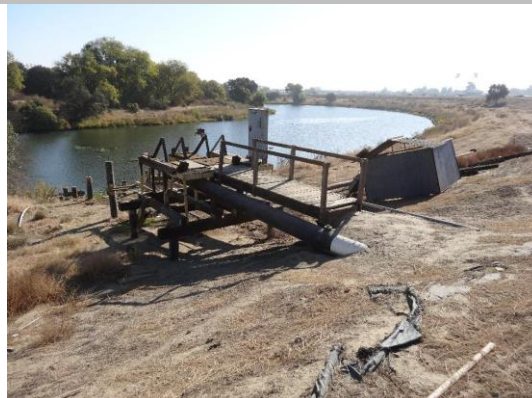
Photo 1 of 3 : UCIP_FA_2018_22809_38913.jpg

Comment Code						
Inspector Comment						
FS_ID:22809 DS_ID:19183 EP_NO: 12679 Repair Type: Non-Urgent Crossing Status: Found UCIP Comments: - All 3 pipes on landside looks new.- Pumps, pump house, and pipes removed from waterside.- Land development activities going on in this area.- Needs to confirm from LMA or DWR Inspector about the crossing. FIELD_STRUCT_DESC: 2 of 3: 16-inch steel irrigation discharge pipe through the levee, 5 feet below the crown. Electrical conduit through the levee. Slant pump in a pump house on the waterside (WS) slope. Siphon breaker on the landside (LS) slope. Service pole and concrete gate valve box at the landside (LS) toe. Installed by USACE in 1961. (Plans to replace rusted portions of two 16-inch irrigation pipes through the levee authorized under Permit No. 16124, 1993 - Reclamation District No. 2062). [Additional Reference(s): DWR Levee Log, 2007. USACE San Joaquin O&M Manual 9, April 1964, (HLM 1.65)]. FS Date: 10/22/2013

LM Start	1.64	Rating **	M	Issue No.	10 (cont)
LM End	1.64	Issue Type +	En	Location *

WS view: pipes, walkway, and dismantled pumphouse (right).

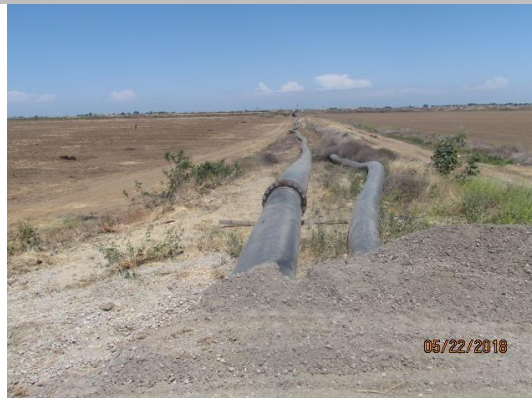
Photo 1 of 4 : FA_2018_RD2062_310_15_20180906_00007.jpg

LM Start	0.57	Rating **	U	Issue No.	15 (cont)
LM End	0.57	Issue Type +	En	Location *	CR

Looking west at pipes on landward slope. (Spring 2018)

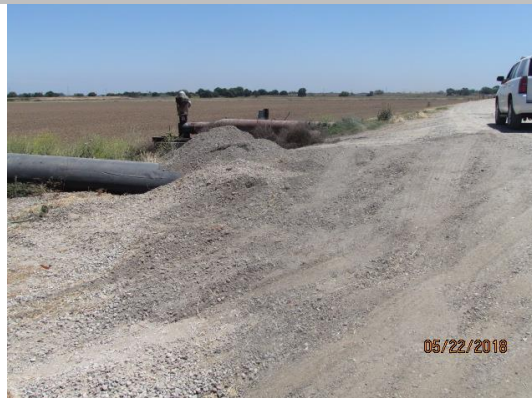
Photo 4 of 4 : FA_2018_RD2062_310_15_20180906_00010.jpg

LM Start	0.57	Rating **	U	Issue No.	15 (cont)	
LM End	0.57	Issue Type +	En	Location *	CR	
Category	Interior Drainage & Piping Systems			GPS Latitude/Longitude		
				Start		End
Item	Encroachments			37.784488 °	37.784488 °	
				-121.339098 °	-121.339098 °	
DWR ID	DWR_RD2062_02_s_2018_15					
Comment Code						
Inspector Comment						
Unauthorized installation.

Looking south at ramp on levee crown. (Spring 2018)

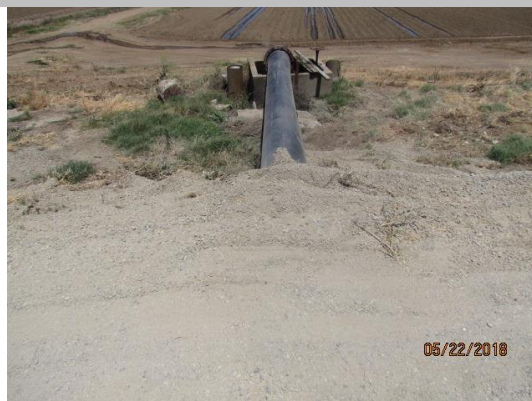
Photo 4 of 5 : FA_2018_RD2062_310_14_20180906_00005.jpg

LM Start	1.37	Rating **	U	Issue No.	14 (cont)
LM End	1.37	Issue Type +	Ma	Location *	CR

Looking west at installation (pipe) on landward slope. (Spring 2018)

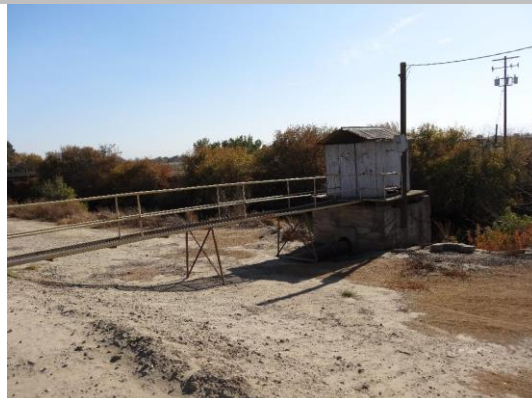
Photo 1 of 3 : UCIP_FA_2018_51468_39195.jpg

Comment Code						
Inspector Comment						
FS_ID:51468 DS_ID:19193 EP_NO: N/A Repair Type: Non-Urgent Crossing Status: Found UCIP Comments: 04/05/2017:Pipe has been plugged as a flood fight measure and is likely to be replaced under a permit. MBK (Michael Moncrief) is working on the permit. Photo and update courtesy of Max Khashchuk as part of his 2017 Spring Inspection. (K. Fazel - UCIP)10/22/2013:- pumphouse on concrete sump in the channel.- erosion under walkway on waterside. (P. Amatya - DWR) FIELD_STRUCT_DESC: 20-inch steel irrigation discharge pipe through the levee, 8 feet below the crown. Pump house on the waterside (WS) slope. Metal walkway from the pump house to the crown. Flap gate, siphon breaker, and concrete distribution box on the landside (LS) slope. [Additional Reference(s): DWR Levee Log, 2007, 18-inch pipe referenced. USACE San Joaquin O&M Manual 9, April 1964, (HLM 1.40), 18-inch pipe referenced]. FS Date: 4/6/2017

LM Start	1.37	Rating **	M	Issue No.	18 (cont)
LM End	1.37	Issue Type +	En	Location *

WS view: pipe, walkway, and pumphouse on levee berm. Service pole on waterside.

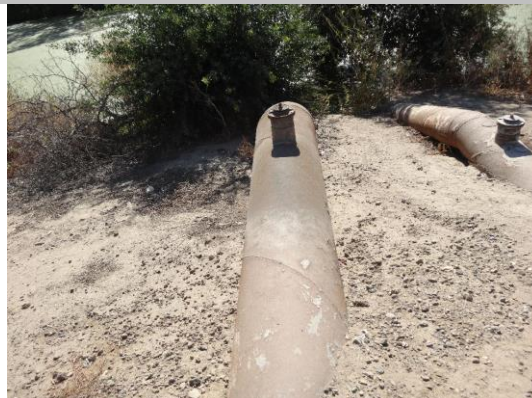
Photo 1 of 3 : UCIP_FA_2018_23304_40147.jpg

LM Start	3.24	Rating **	M	Issue No.	21 (cont)
LM End	3.24	Issue Type +	En	Location *

WS view: 24-inch steel pipe (left) with siphon breaker on levee slope. 18-inch pipe on right.

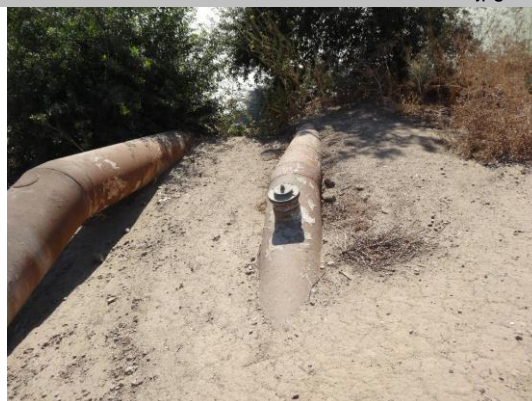
Photo 1 of 3 : UCIP_FA_2018_23023_39082.jpg

LM Start	3.24	Rating **	M	Issue No.	22 (cont)
LM End	3.24	Issue Type +	En	Location *

WS view: exposed 18-inch pipe with siphon breaker on levee slope.
Exposed 24-inch pipe (left).

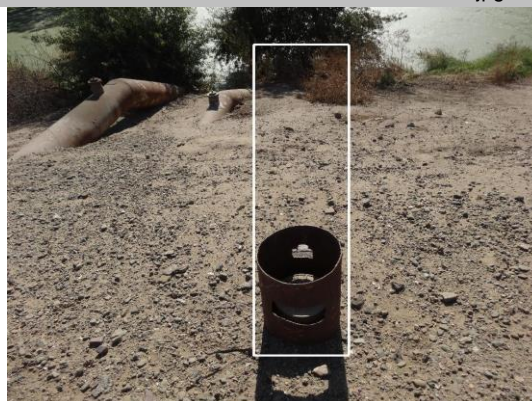
Photo 1 of 3 : UCIP_FA_2018_23305_40153.jpg

LM Start	3.24	Rating **	M	Issue No.	23 (cont)
LM End	3.24	Issue Type +	En	Location *

WS view: siphon breaker in steel pipe riser on levee slope.

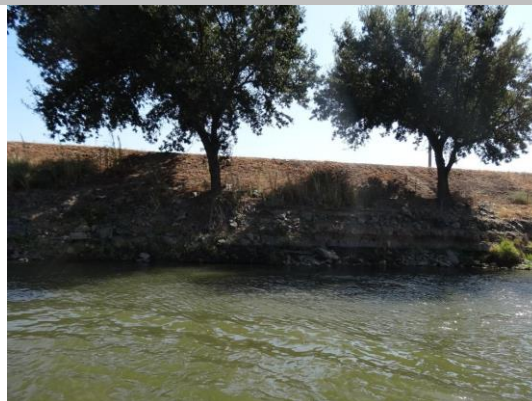
Photo 1 of 4 : FA_2018_RD2062_311_2_20180906_00005.jpg

Comment Code					
Inspector Comment					
09/13/2017: The erosion site has expanded significantly with the erosion length increased to approximately 90 ft from 40 ft. Signs of animal activities have been found at the site.					
07/25/2016: No significant change observed.					
06/25/2015: No significant change observed.					
07/02/2014: No significant change observed.					
08/13/2013: No significant change observed.					
08/07/2012: The site has been visited by boat survey. No significant change observed					
08/23/2011: Hard to view the erosion because of the dense vegetation and trees on site. The site is under the bush, close to the tree. [2017 Site ID:RD2062U03RM30.02]

Front view of the site.

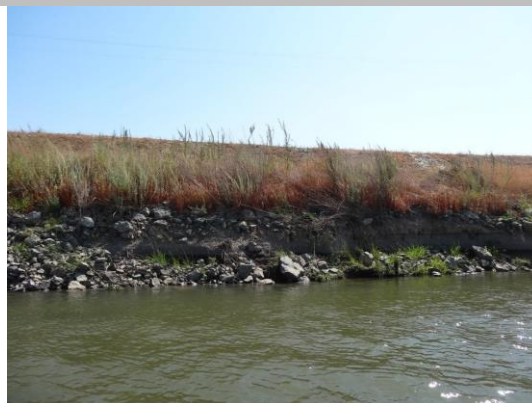
Photo 1 of 3 : FA_2018_RD2062_311_3_20180906_00009.jpg

LM Start	0.17	Rating **	M	Issue No.	3
LM End	0.17	Issue Type +	Ma	Location *	WS
Category	Supplemental			GPS Latitude/Longitude	
				Start	End
Item	DWR Erosion Survey			37.810268 °	37.810268 °
				-121.387495 °	-121.387495 °
DWR ID	DWR_RD2062_03_s_2018_3				
Comment Code					
Inspector Comment					
09/13/2017: No significant change observed.					
07/25/2016: No significant change observed.					
06/25/2015: No significant change observed.					
07/02/2014: No significant change observed.					
08/13/2013: No significant change observed.					
08/07/2012: The site has been visited by boat survey. No significant change observed					
08/23/2011: The protection at the levee toe has been washed away.					
[2017 Site ID:RD2062U03RM30.1]

Direct view of the site.

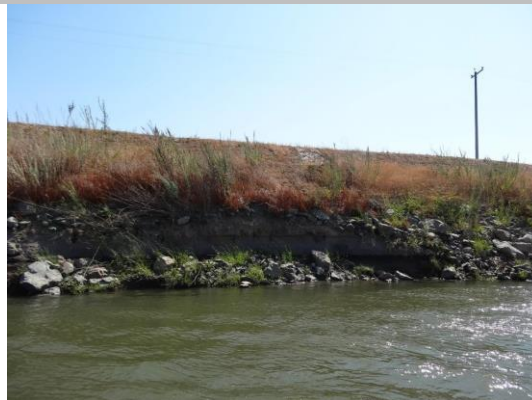
Photo 2 of 3 : FA_2018_RD2062_311_3_20180906_00010.jpg

LM Start	0.17	Rating **	M	Issue No.	3 (cont)
LM End	0.17	Issue Type +	Ma	Location *	WS

Close view of the erosion.

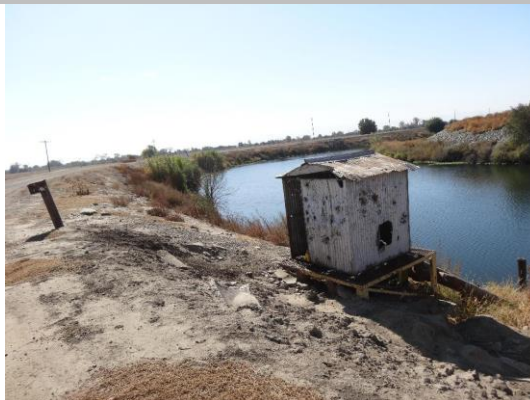
Photo 1 of 3 : UCIP_FA_2018_53377_40158.jpg

LM Start	0.51	Rating **	U	Issue No.	39 (cont)
LM End	0.51	Issue Type +	En	Location *

WS view: pump house on levee slope and soil erosion on levee slope.

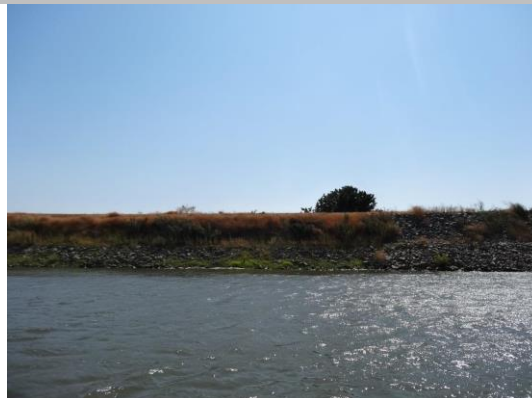
Photo 3 of 3 : FA_2018_RD2062_311_8_20180906_00024.jpg

09/28/2009: No major change observed; section of rip rap has slipped, creating a terraced effect; dense vegetation growth; recommended as a local maintenance issue, per CLRO CES Evaluation 2008 Report; Site # is the same as RM31.12,LM1.25; previously rated "U".						
09/14/2006: 1-2' into prism. [2017 Site ID:RD2062U03RM31.12]

Front view of the site.

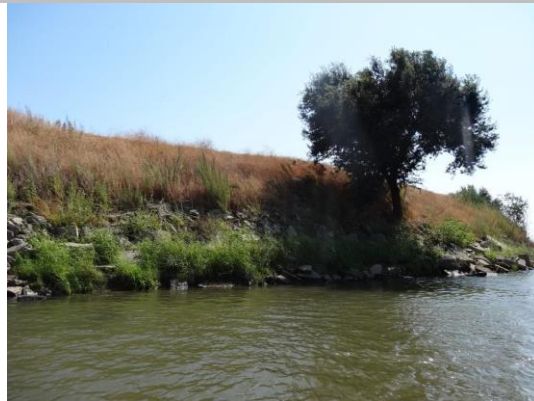
Photo 4 of 4 : FA_2018_RD2062_311_9_20180906_00028.jpg

Close view of the site.

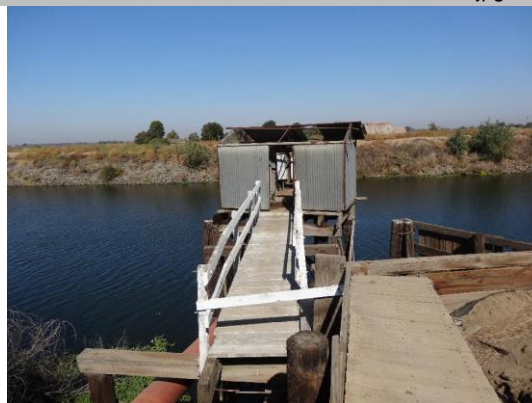
Photo 1 of 3 : UCIP_FA_2018_23311_40175.jpg

Comment Code					
Inspector Comment					
FS_ID:23311 DS_ID:19202 EP_NO: 2505 Repair Type: Non-Urgent Crossing Status: Found UCIP Comments: - pumphouse roof missing.- siphon breaker buried by dirt in CMP riser.- 2.25 inch electric conduit and power pole on landside. FIELD_STRUCT_DESC: 2 of 2: 16-inch irrigation discharge pipe of an unknown material through the levee, 6.5 feet below the crown. Pump in a pump house on a pile structure in the stream. Timber walkway to the pump. Siphon breaker in a corrugated metal pipe (CMP) riser on the landside (LS) slope. Concrete distribution box at the LS toe. Timber bulkhead and slab on the waterside (WS) slope. Installed by USACE in 1963. (Plans for the installation of two irrigation pumps on the bank to replace an existing pumping plant at this location authorized under Permit No. 2505, 1959 - Reclamation District No. 2062). [Additional Reference(s): DWR Levee Log, 2007. USACE San Joaquin O&M Manual 9, April 1964, (HLM 2.81)]. FS Date: 10/22/2013

WS view: wooden walkway to pumphouse, pumphouse on wooden pile structure in the stream.

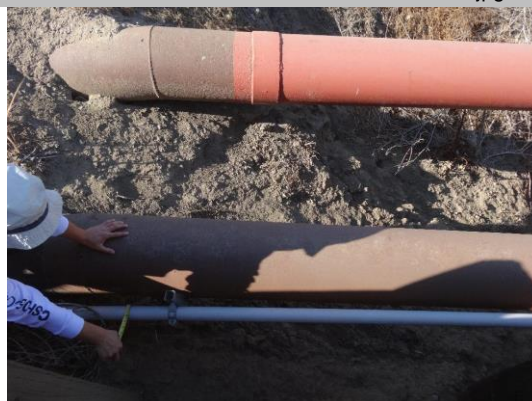
Photo 2 of 3 : UCIP_FA_2018_23311_40174.jpg

LM Start	2.77	Rating **	M	Issue No.	40 (cont)
LM End	2.77	Issue Type +	En	Location *

WS view: exposed steel pipes and an electric conduit on levee slope.

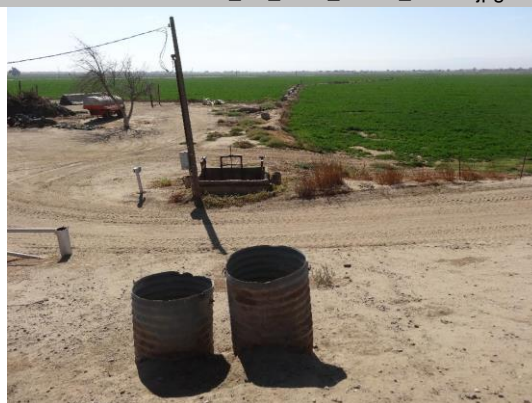
Photo 3 of 3 : UCIP_FA_2018_23311_40173.jpg

LS view: two CMP risers on levee slope, concrete distribution box, and service pole across the dirt road, off the levee toe.

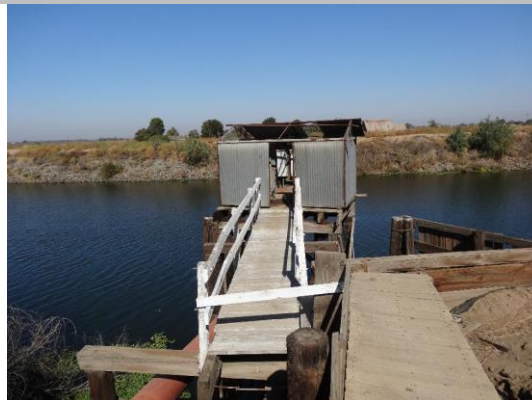
Photo 1 of 3 : UCIP_FA_2018_23312_40181.jpg

LM Start	2.77	Rating **	M	Issue No.	41 (cont)
LM End	2.77	Issue Type +	En	Location *

WS view: wooden walkway to pumphouse, pumphouse on wooden pile structure in the stream.

Comment Code						
Inspector Comment						
FS_ID:23312 DS_ID:19205 EP_NO: 2505 Repair Type: Non-Urgent Crossing Status: Found UCIP Comments: - pumphouse roof missing.- siphon breaker buried by dirt in CMP riser.- 2.25 inch electric conduit and power pole on landside. FIELD_STRUCT_DESC: 1 of 2: 14-inch irrigation discharge pipe of an unknown material through the levee, 6.5 feet below the crown. Pump in a pump house on a pile structure in the stream. Timber walkway to the pump. Siphon breaker in a corrugated metal pipe (CMP) riser on the landside (LS) slope. Concrete distribution box at the LS toe. Timber bulkhead and slab on the waterside (WS) slope. Installed by USACE in 1963. (Plans for the installation of two irrigation pumps on the bank to replace an existing pumping plant at this location authorized under Permit No. 2505, 1959 - Reclamation District No. 2062). [Additional Reference(s): DWR Levee Log, 2007. USACE San Joaquin O&M Manual 9, April 1964, (HLM 2.81)]. FS Date: 10/22/2013

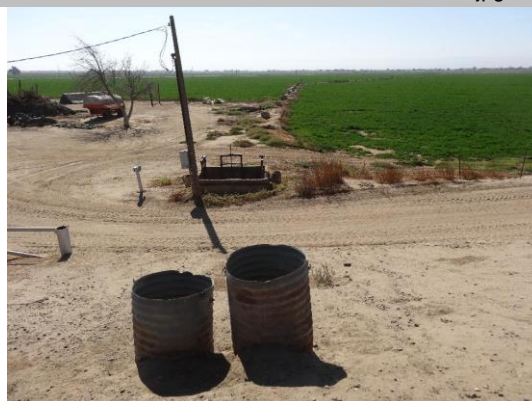
Photo 3 of 3 : UCIP_FA_2018_23312_40180.jpg

LS view: two CMP risers on levee slope, concrete distribution box, and service pole across the dirt road, off the levee toe.

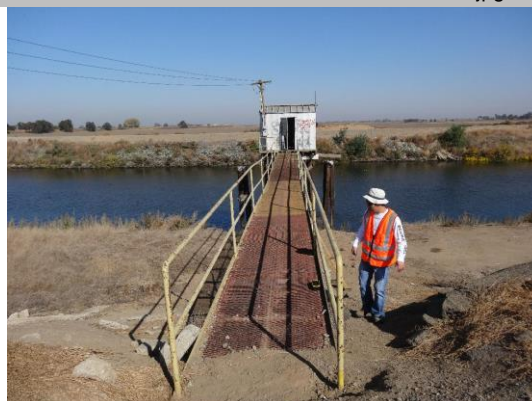
Photo 1 of 3 : UCIP_FA_2018_23142_39549.jpg

LM Start	5.37	Rating **	M	Issue No.	42 (cont)
LM End	5.37	Issue Type +	En	Location *

WS view: steel walkway to pump house in the stream.

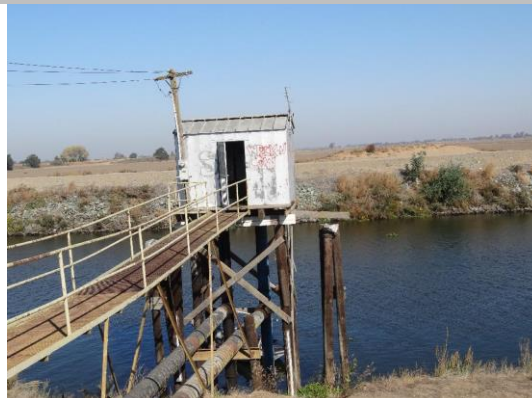
Photo 3 of 3 : UCIP_FA_2018_23142_39547.jpg

Comment Code						
Inspector Comment						
FS_ID:23142						
DS_ID:19203						
EP_NO: N/A						
Repair Type: Non-Urgent						
Crossing Status: Found						
UCIP Comments: - siphon breakers not protected.- flow meter and gage station on waterside.- pump house on wooden pile structure.						
Walkway to the pumphouse.						
FIELD_STRUCT_DESC: 1 of 2: 16-inch irrigation discharge pipe of an unknown material through the levee, 4 feet below the crown. Pump in a pump house on a pile structure in the stream. Walkway to the pump house. Siphon breaker on the landside (LS) slope. Concrete distribution box on the LS berm. [Additional Reference(s): DWR Levee Log, 2007. USACE San Joaquin O&M Manual 9, April 1964, (HLM 5.45)].						
FS Date: 10/22/2013

WS view: pump house on wooden pile structure in the stream. Two steel pipes under the walkway.

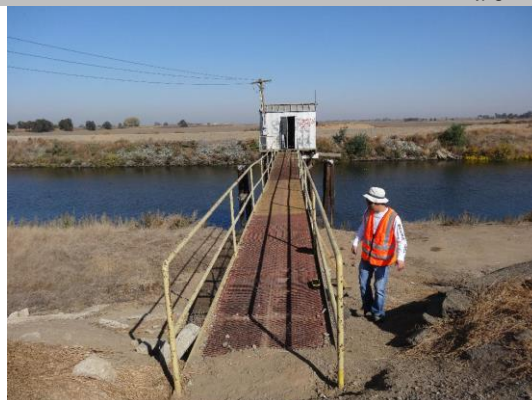
Photo 1 of 3 : UCIP_FA_2018_23140_39531.jpg

LM Start	5.37	Rating **	M	Issue No.	43
LM End	5.37	Issue Type +	En	Location *	
Category	Supplemental			GPS Latitude/Longitude	
				Start	End
Item	DWR UCIP Field Study			37.807305°	37.807305°
				-121.331276°	-121.331276°
DWR ID	19206

Comment Code					
Inspector Comment					
FS_ID:23140					
DS_ID:19206					
EP_NO: N/A					
Repair Type: Non-Urgent					
Crossing Status: Found					
UCIP Comments: - siphon breakers not protected.- flow meter and gage station on waterside.- pump house on wooden pile structure.					
Walkway to the pumphouse.					
FIELD_STRUCT_DESC: 2 of 2: 16-inch irrigation discharge pipe of an unknown material through the levee, 4 feet below the crown. Pump in a pump house on a pile structure in the stream. Walkway to the pump house. Siphon breaker on the landside (LS) slope. Concrete distribution box on the LS berm. [Additional Reference(s): DWR Levee Log, 2007. USACE San Joaquin O&M Manual 9, April 1964, (HLM 5.45)].					
FS Date: 10/22/2013

WS view: steel walkway to pump house in the stream.

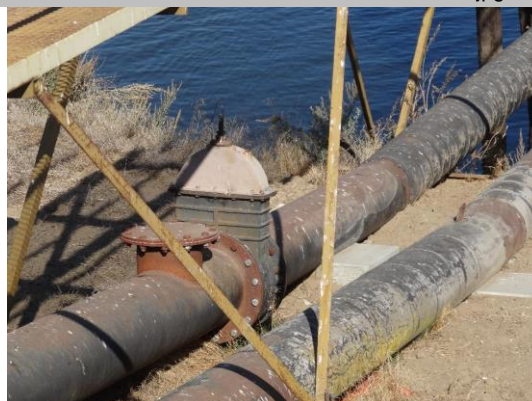
Photo 2 of 3 : UCIP_FA_2018_23140_39530.jpg

LM Start	5.37	Rating **	M	Issue No.	43 (cont)
LM End	5.37	Issue Type +	En	Location *

WS view: two 16-inch pipes under walkway. Gate valve without handle on one of the pipes.

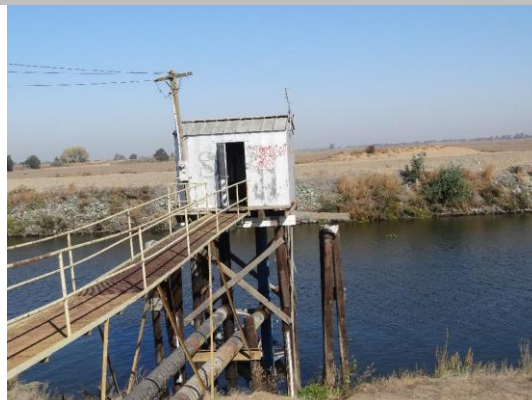
Photo 3 of 3 : UCIP_FA_2018_23140_39529.jpg

WS view: pump house on wooden pipe structure in the stream. Two steel pipes under the walkway.
